# Manhole Inspection Summary

Manhole # S33KK\_048MH

**Location** Address: **1814 MARYLAND AVE**

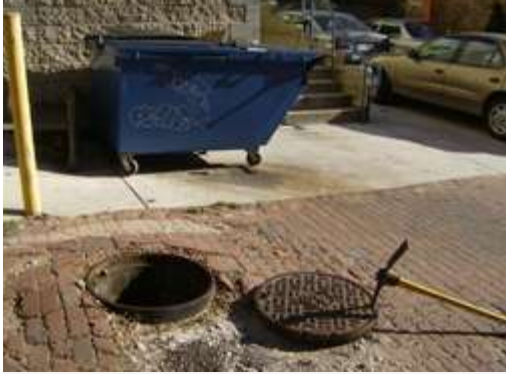
Location View

grade 3 inches

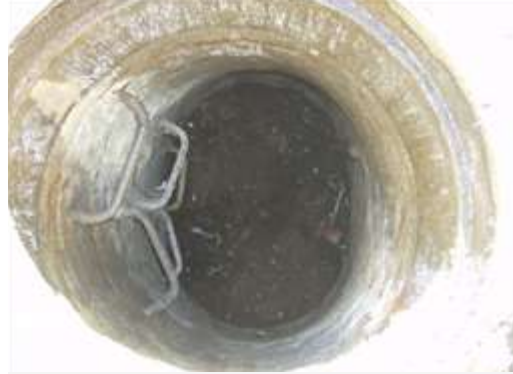
Top View

Channel debris.

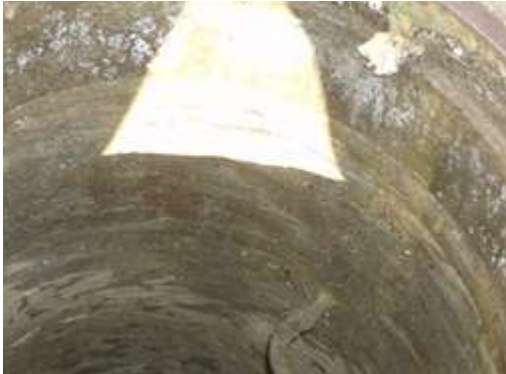
Defect

Infiltration: ☐ None ☒ **Joint** ☐ Cracks ☐ Mortar ☐ Roots ☒ **Wall**

Adjustment and Barrel infiltration.

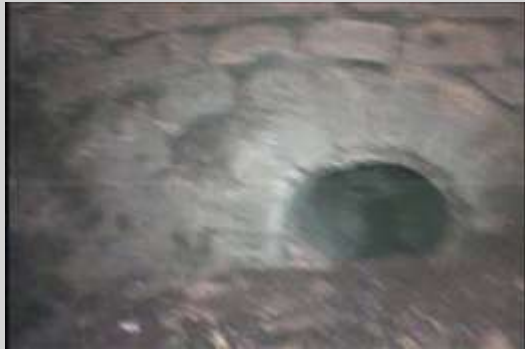
8 in. Circular Gravity Sewer  
Pipe Out @ 12 O'Clock

Condition: ☐ Sound ☐ Cracked ☐ Root Intrusion ☐ Loose Brick ☒ **Deteriorated**

Infiltration: ☐ None ☐ Joint ☐ Cracks ☒ **Mortar** ☐ Roots ☒ **Wall**

Barrel deterioration and infiltration.
